BEACH EROSION CONTROL REPORT ON COOPERATIVE STUDY OF FALMOUTH MASSACHUSETTS

**U.S. ARMY ENGINEER DIVISION, NEW ENGLAND
CORPS OF ENGINEERS**

**WALTHAM, MASS.
DECEMBER 28, 1962**

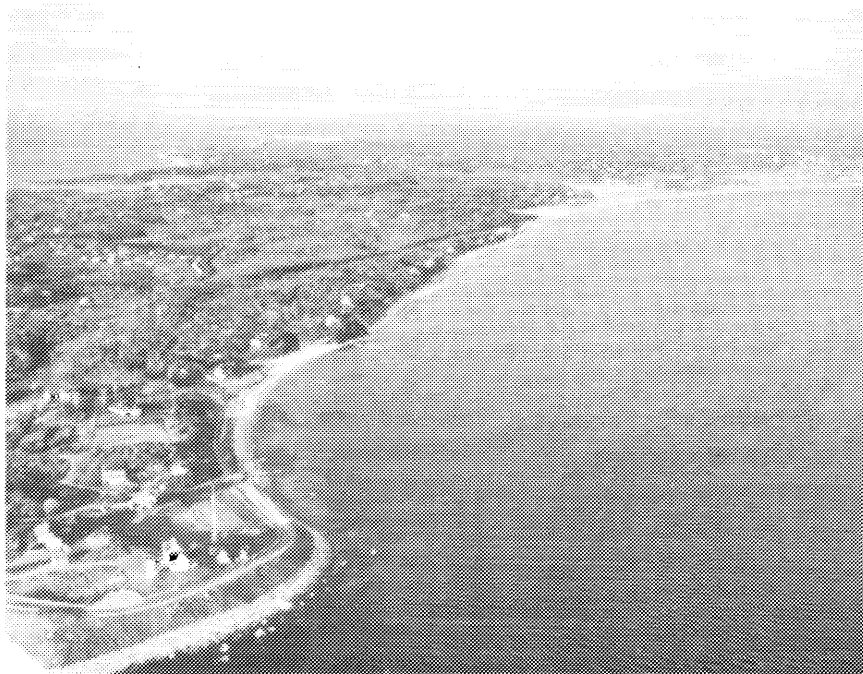
PHOTO 1 NOBSKA POINT TO FALMOUTH BEACH
Nov 27, 1961 - Nobska Point in foreground

18. Nobska Point. - Nobska Point is located at the west limit of the study area. The shore has a length of 2,200 feet including 1,250 feet around the tip of the point, owned by the town and 950 feet extending eastward from the tip, privately owned. Development, all landward of the road bordering the shore, consists of a United States Coast Guard Station behind the town property and residences behind the private shore. The outer end of Nobska Point is a glacial till headland with a steep seaward slope protected by a stone mound and riprap revetment. The sandy shore and road to the east are protected by riprap revetment and the remains of stone groins.

Construction of the stone mound and revetment around 1,100 feet of the tip of the point during 1959 provided needed protection for the former eroding bluff and the shore road behind it. Except for maintenance of small areas where a few stones were displaced, apparently the result of loss of the underlying sand and gravel, no additional work is needed around the tip of the point. The elevation of the road, which closely borders the shore, drops to the east and it is subject to overtopping during high storm tides. This does not create a particularly serious problem since the residential development is located on higher ground well behind the shore. Protection, if desired, can be provided by reconstructing the road at a higher elevation and placement of riprap revetment along the face of the road embankment. In general, maintenance of the existing stone mound and riprap revetment should provide suitable protection for this area.

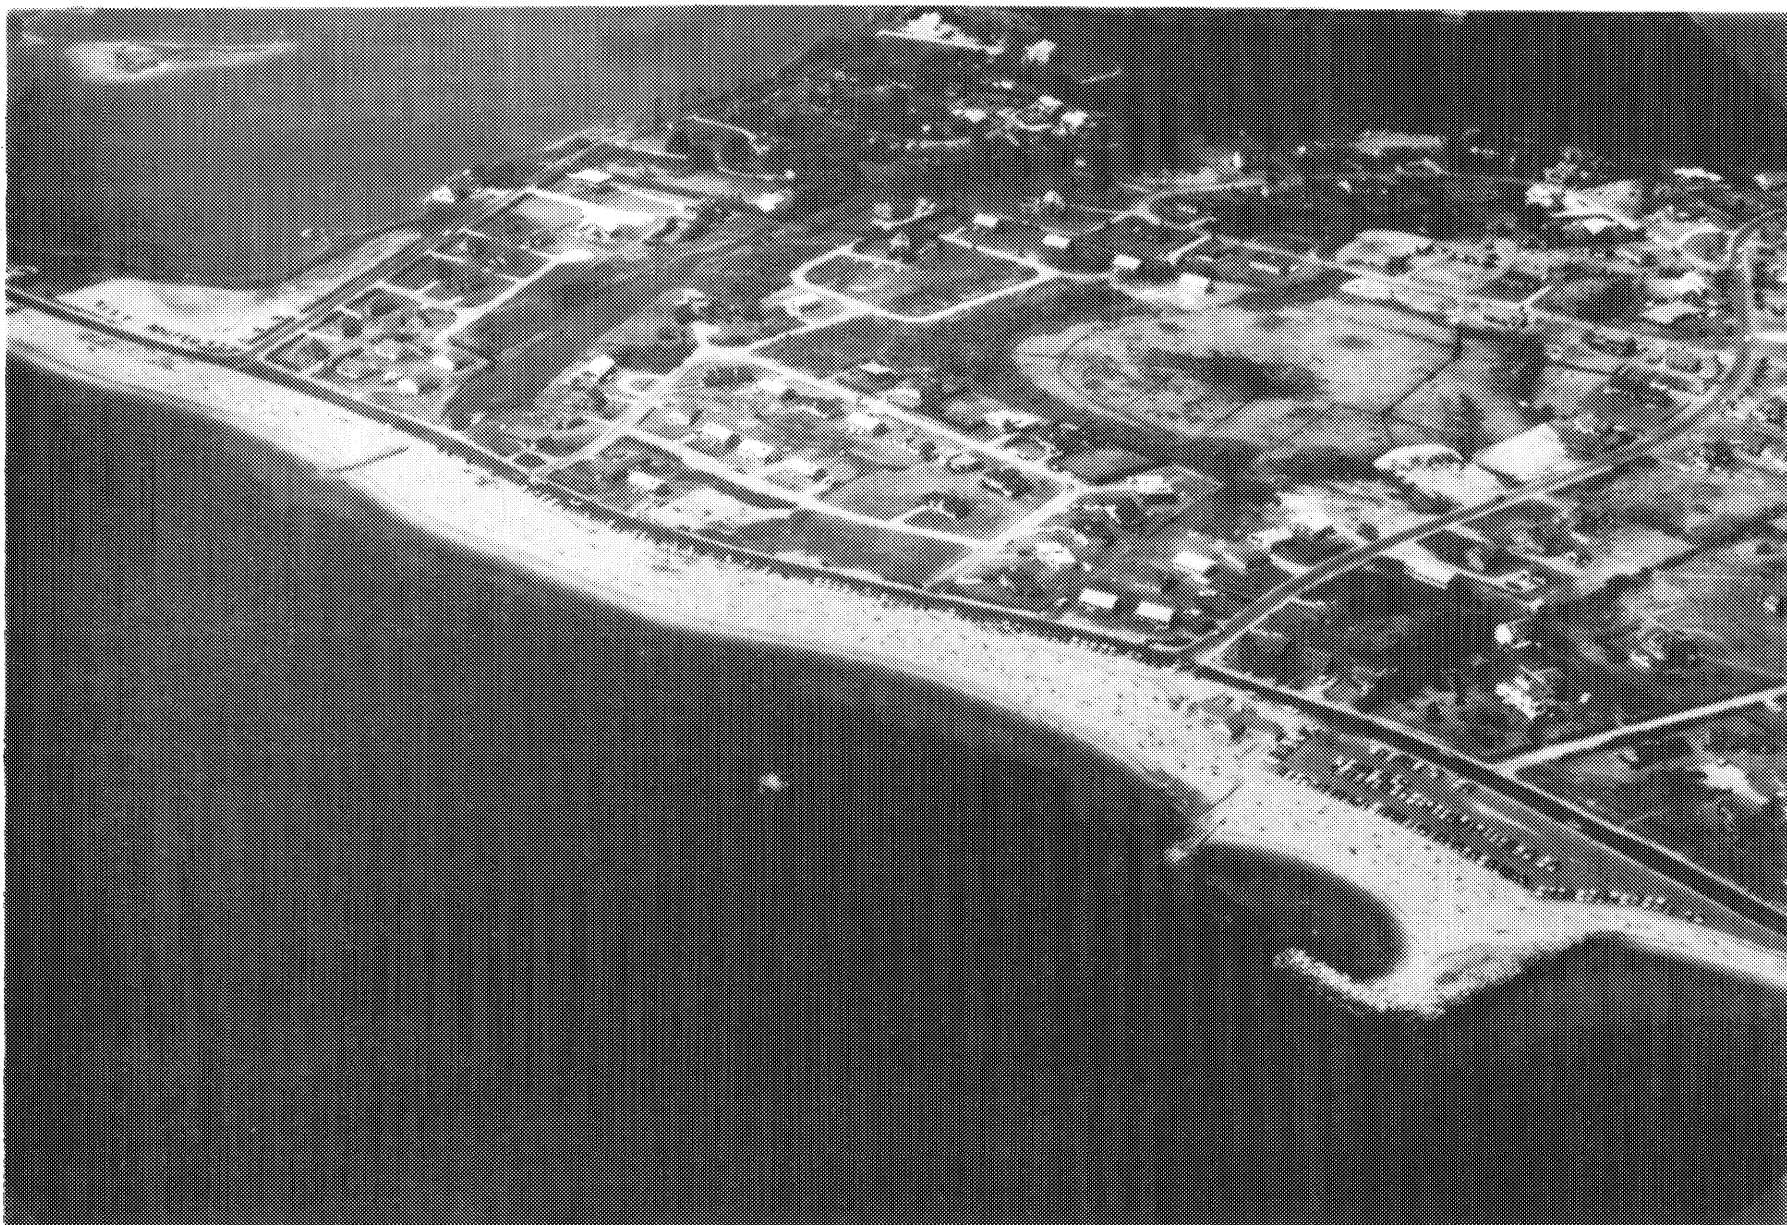
PHOTO 3 FALMOUTH BEACH (EAST END) - Aug 26, 1962. Sunday attendance at the public bathing beach.

bordered by a town road with residences along its landward side. The beach width between the high water line and the shore road increases eastward from about 70 to 160 feet. The beach composition is finer to the east. It consists of coarse and medium sand with the backshore partially covered with low-grassed sand dunes. Two stone jetties across the beach train the flow of a culvert which drains Siders Pond. There are two shore-connected curved stone breakwaters at the east end of this shore which act as a littoral barrier impounding a sand beach to the west. The parking lot at the bathhouse is protected by stone revetment and a bulkhead. The shoreline in 1961 was generally at or seaward of its position in 1845 indicating that the beach is stable or benefitting from accretion. The beach is in good condition. Some landward movement of sand over the shore road occurs as a result of wind or wave action but the beach is generally wide enough to protect the development landward of it from storm damages. It is possible that due to lack of a natural source of supply of beach building materials that erosion and recession of the shore may occur at some future time. In this event, the sand beach could be maintained by placement of sand fill either directly on the beach or in stockpiles located to the west to be distributed by eastward drifting. There is no present apparent need for such nourishment. Drifting of sand and formation of a sand bar between the jetties at the Siders Pond culvert periodically stops the drainage causing a problem of local concern. Correction of this problem could be effected by either seaward extension of the jetties to prevent drifting of sand around their ends or by seaward extension of the drain. Extension of the jetties or drain out to a depth of six feet would probably be adequate. The extension of the jetties by interfering with the natural drifting of sand might have an adverse effect on the adjacent shore. The drain extension would have the advantage of permitting free movement of sand along the beach over the culvert and elimination of the need for jetties.

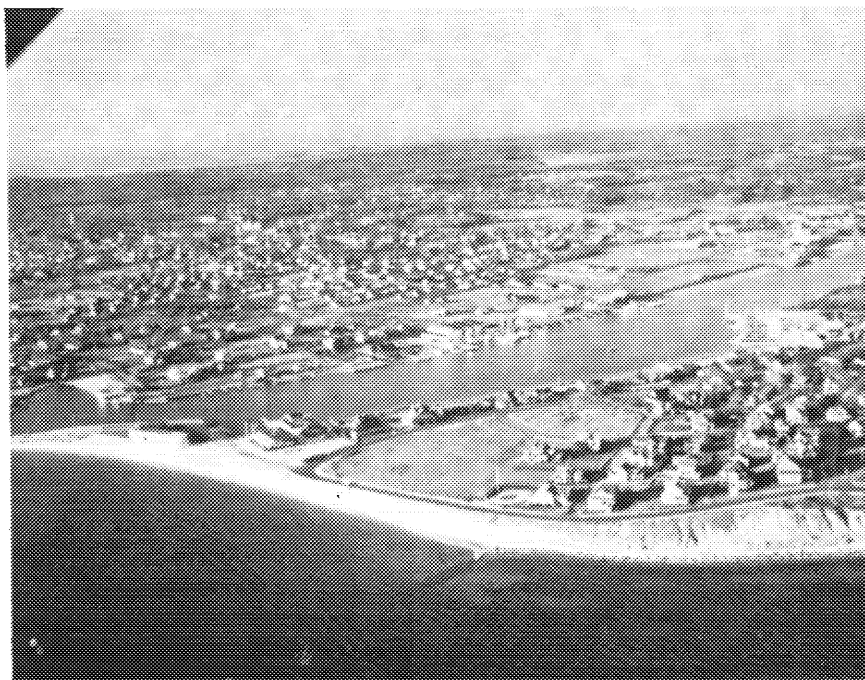
PHOTO 4 FALMOUTH HEIGHTS, Nov 27, 1961 -
From Falmouth Inner Harbor entrance to
bluffs.

23. Between Falmouth Beach and Falmouth Inner Harbor. - The shore extending eastward about 2,400 feet from Falmouth Beach to the west jetty at the Falmouth Inner Harbor entrance is privately owned. Development consists of residences generally located well behind the shoreline. The development and the shore are protected by a variety of structures consisting of stone mounds, riprap revetment, stone, timber and concrete groins and stone and concrete walls. Along the west end of the area a stone mound is located at the shoreline with no fronting beach. In the central portion of the area there is a sand beach about 40 feet wide fronting protective structures and this beach width increases eastward to about 150 feet at the harbor jetty. The beach is composed of coarse to medium sand, with gradation finer to the east. During periods prior to 1941, the shore, except adjacent to the west jetty, has receded up to about 1 foot per year. The west jetty, constructed in 1909 resulted

in accretion adjacent to it of about 150 feet to 1941 and another 100 feet up to 1961. No other significant changes occurred within the area from 1941 to 1961 indicating that existing structures have stabilized the shore. If additional protection is desired, it can be effected by direct placement of sand fill along the shore to provide a wider sand beach. The use of a stockpile west of the area would probably not be effective due to the existence of the breakwaters at Falmouth Beach which act as a littoral barrier. Eastward drifting of sand placed along the shore could result in narrowing of the west end of the fill and filling of the west jetty at the Falmouth Inner Harbor entrance to the limit of its impounding capacity with consequent movement of sand around the jetty into the harbor entrance. Prevention of harbor shoaling under these conditions would require extension of the jetty. Eastward drifting could be reduced by construction of groins west of the jetty to hold a beach of the desired width. This might eliminate the need for extension of the jetty. Under conditions of present use, existing structures, if maintained, should provide adequate protection for the development although during exceptional storms or hurricanes overtopping and flooding could occur.

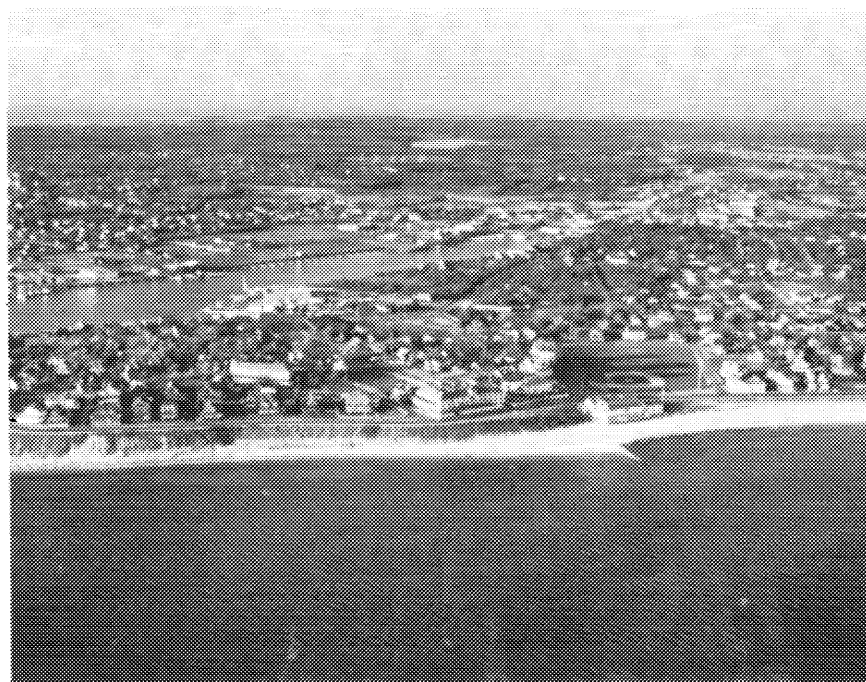
PHOTO 5 FALMOUTH HEIGHTS, Nov 27, 1961 -
The bluffs, Casino and public bathing beach

26. Due to erosion and narrowing of the beach, the concrete seawall fronting the bluff is subject to damages from wave attack and undermining. Erosion of parts of the unprotected face of the bluff above the wall occurs but this erosion is due more to surface runoff than to overtopping. Protection against undermining and wave attack can be provided by placement of additional riprap along the toe of the wall. Erosion of the bluff above the wall can be prevented by interception or control of surface runoff and by extending the existing stone slope protection. A typical section showing this type of protection is shown on Plate 11.

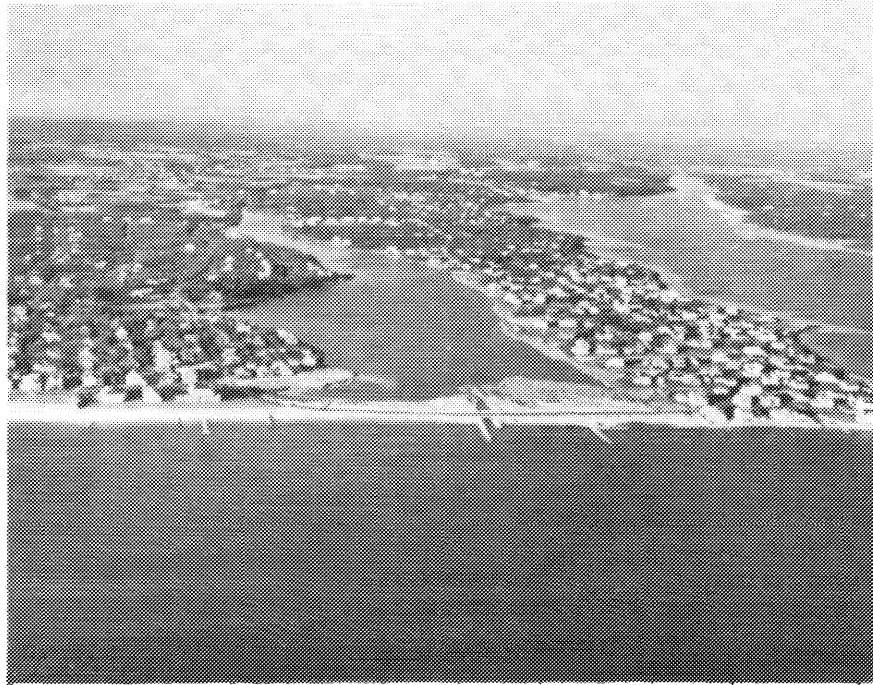
PHOTO 7 FALMOUTH HEIGHTS, LITTLE POND
AND MARA VISTA - Nov 27, 1961

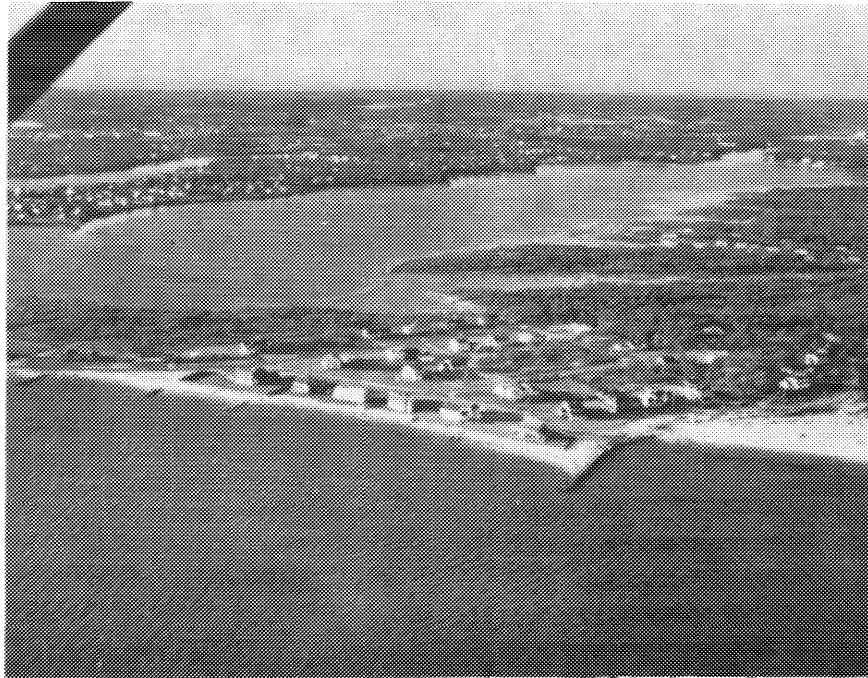
PHOTO 9 ACAPESKET, Nov 27, 1961 - Great Pond
in background

30. Acapesket. - The Acapesket shore located between the jetties at the Great and Green Pond Inlets has a length of approximately 2,750 feet. Ownership is entirely private. Development consists of cottages on the landward side of the shore road along the westerly third of the area and on both sides in the central portion. The barrier bar fronting Green Pond along the easterly third of the shore is undeveloped. The beach is composed of medium and coarse sand and some gravel. Its width above high water varies irregularly. There is little or no beach along the west end where the shore road, closely bordering the shore, is protected by rip-rap, and a curved face precast concrete block wall and stone groins.

In the central portion, the sand beach varies from 0 to 80 feet, the greater width at the west sides of stone groins. In this area, cottages on the seaward side of the shore road are protected by stone groins, a stone mound, riprap and timber bulkheads. The barrier bar fronting Green Pond has a width of 200 to 300 feet and it is partially covered with grassed sand dunes. Shoreline changes along the entire Acapesket shore have been large over the period of record. Between 1845 and 1941, the shoreline receded at an average rate of 2 to 4 feet per year, the larger recession along the east half. From 1941 to 1961 the barrier bar fronting Green Pond and a segment of shore adjacent to the Great Pond Inlet receded up to about 200 feet more while changes along the rest of the area were comparatively small. Due to the narrowness of the beach fronting the shore road and the shore cottage development, the area is subject to damages from erosion, wave attack and overtopping. Some settlement of the precast concrete block wall which protects the shore road has occurred and the lawns fronting cottages are subject to erosion resulting from overtopping of the beach and existing protective structures. A large measure of protection is already afforded by existing protective works. Complete protection could be provided by construction of higher walls or barriers and armoring the shore with more riprap revetment. Due to the limited development which would benefit, provision of complete protection does not appear to be warranted. Partial protection can be provided by placement of a wider protective sand beach. The high rate of past shoreline recession indicates that beach fill material would be lost at a fairly rapid rate and that construction of groins to reduce fill losses would be necessary. A plan of protection involving placement of a wider protective sand beach and enlargement of existing groins to reduce fill losses has been developed in the event that prospective use or benefits should warrant such construction. The plan is shown on Plate 11. Maintenance of the existing system of protective works should generally provide the type of protection needed under present conditions of use.

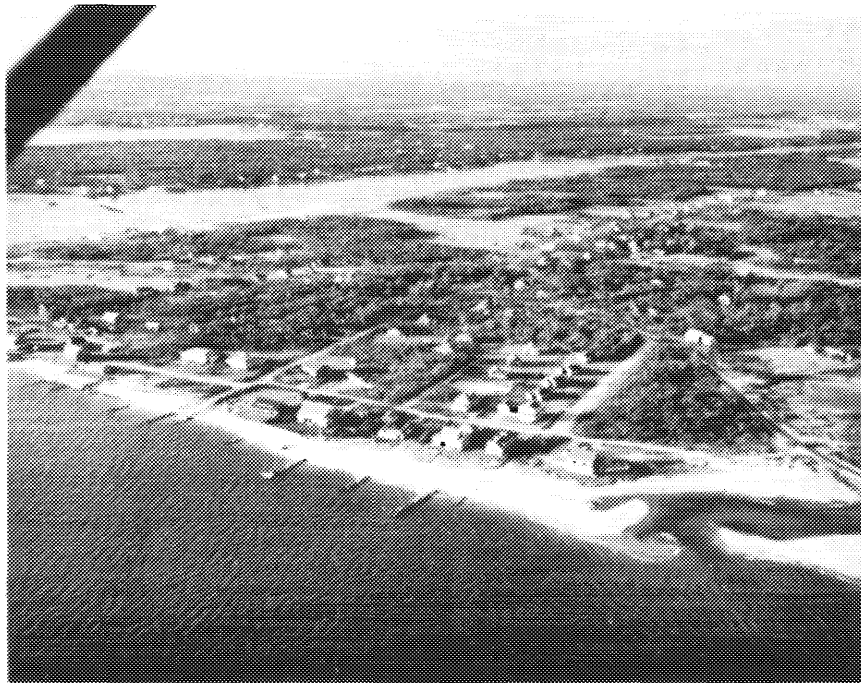
PHOTO 10 DAVISVILLE AND BOURNES POND
INLET - Nov 27, 1961

During the period of record, from 1845 to 1941, the shoreline receded an average of 1 to 4 feet per year, with the largest shore loss at the west end. Since 1941, recession generally less than 25 feet, occurred along the west half and a seaward shoreline movement of 25 to 50 feet occurred along the east half of the shore. The reduction in the rate of shore recession and the accretion which has occurred since 1941 indicates that the existing protective structures have been successful in controlling erosion. Some erosion of the low bluff ~~and lawns~~ behind the beach occurs where the bluff has not been protected. Armoring the bluff by construction of stone mounds or placement of riprap revetment has provided effective protection in this area. The groins have been effective in reducing erosion. In the absence of natural sources of supply of beach building materials, these methods would not provide an adequate width of fronting protective sand beach. Unless such a supply is furnished, losses of the existing sand beach will gradually expose the area to more severe wave attack and require the construction of increasingly stronger protective works. A protective sand beach can be provided by direct placement of sand fill. Construction of groins would be necessary to reduce rapid losses of the fill. A plan of protection and improvement involving beach widening by fill placement, construction of a jetty at the Bournes Pond Inlet and construction of two new groins has been developed for possible future use and it is shown on Plate 12. Beach widening can also be effected by placing sand fill at the west end of the area and allowing it to nourish the shore by eastward drifting. Construction of a jetty would be required at the east end of the area to impound drifting sand and protect Bournes Pond Inlet from shoaling. This method of nourishment would be ~~accompanied~~ by a higher rate of loss of fill than the plan involving groin construction. Under present conditions of use and exposure, maintenance of existing or construction of additional seawalls, stone mounds, revetments or groins should provide adequate protection.

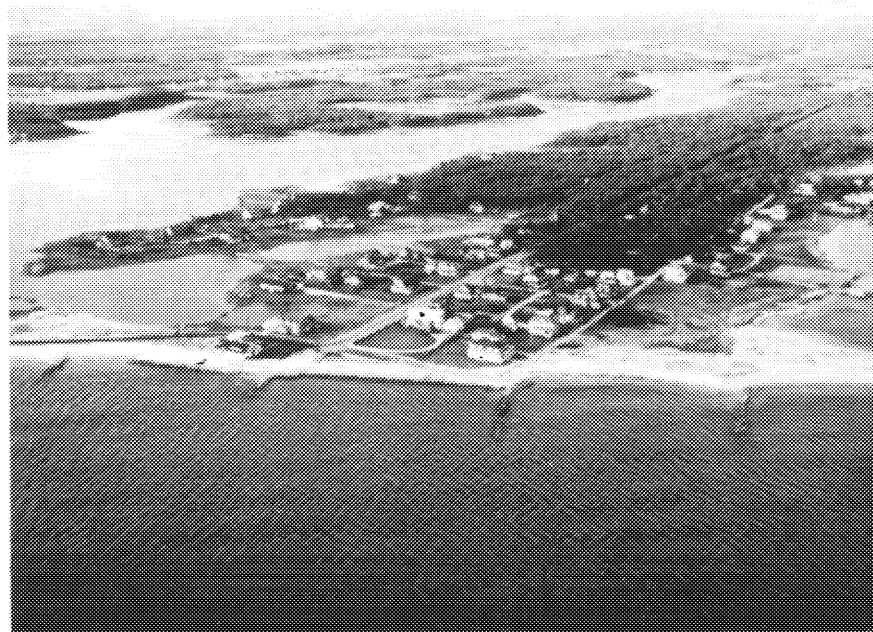
PHOTO 12 MENAUHANT, Nov 27, 1961. - Low
shore between Bournes and Eel Ponds

32. Menauhant. - The Menauhant shore, located between the Bournes Pond and Eel Pond Inlets consists of 1,850 feet of town-owned public bathing beach and 1,500 feet of privately-owned shore. The public beach is on a low sandy barrier bar fronting Bournes Pond. The road on the bar is protected by dumped riprap where it closely borders the shore. The fronting sandy beach varies irregularly in width from about 130 to 20 feet and it is protected by a series of 4 stone groins. There are no buildings on the bar. The private shore to the east is protected by 3 stone groins and a stone jetty at the Eel Pond Inlet, the two westerly structures fronting a residential development, the other two on an undeveloped sandy barrier bar at Eel Pond. There is a stone mound fronting the residential development with little or no width of sandy beach in front of the mound. The ~~sandy~~ barrier bar at Eel Pond is about 200

feet wide. Except for one residence, all buildings are located on the landward side of the shore road. Between 1845 and 1942, the entire shore receded at an average rate of 1 to 3 feet per year. From 1942 to 1961, along the west half of the Menauhant shore, there was a seaward shoreline movement of 25 to 50 feet and during the same period the shore fronting Eel Pond receded a similar amount. The beach and barrier bars are low in elevation and subject to overtopping during storms accompanied by high tides. Damages occur along the residential development and the public shore area to the west where beach material moves landward over the shore road and onto lawns. The road is subject to damages from wave attack where the beach width is inadequate to provide protection. Some erosion of lawn areas also occurs. Consideration has been given by local interests to construction of a new bridge over Bournes Pond Inlet and relocation of the Menauhant shore road at a higher elevation along the landward side of the barrier bar. This would make it possible to provide complete protection for the road without interfering with or impairing the recreational use of the beach. Complete protection can be provided for the entire shore area by construction of high seawalls or other barriers seaward of the shore road and buildings but this is not warranted by the limited development which would benefit. Improvement and partial protection of the public shore and road and the private development can be provided by placement of sand fill to create a wider sand beach and construction of a low seawall along the seaward edge of the road. The history of recession of the shore indicates that groins would be required to reduce the rapid loss of the fill. A plan of protection and improvement involving beach widening along the private residential area and the narrow portion of the adjacent public bathing beach, the construction of a low seawall and the enlargement of three existing groins to reduce losses of the beach material has been developed for use in the event that future development or recreational use of the shore should warrant it. The plan is shown on Plate 12. The beach could also be widened and nourished by placing a stockpile of sand at the west end of the area and allowing the sand to drift eastward. Losses of fill would be higher using this method than with the fill plan involving groin construction. Maintenance of existing protective structures appears to be all that is warranted for present or prospective use of the barrier bar fronting Eel Pond.

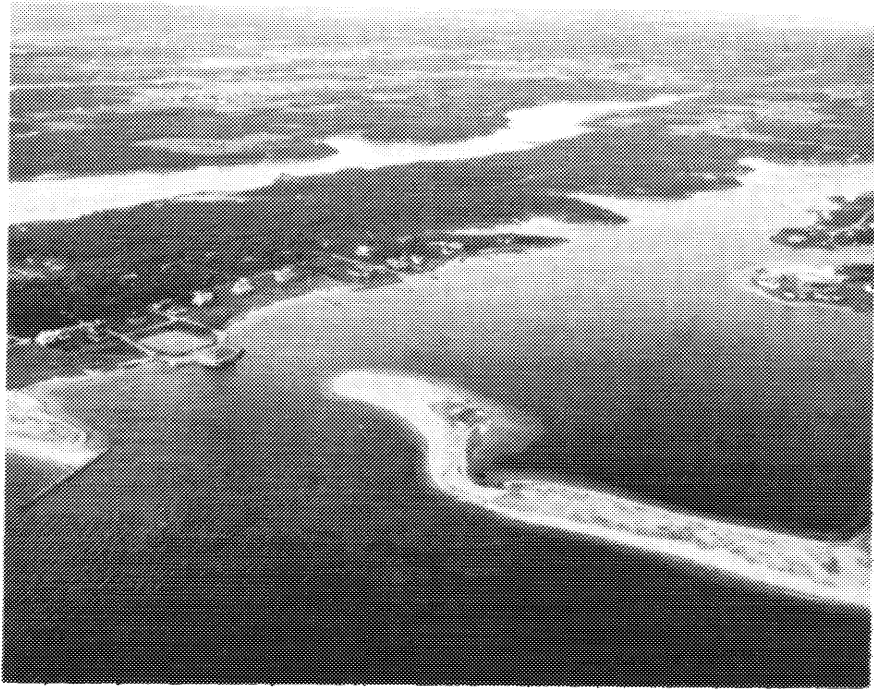
PHOTO 13 EEL POND INLET, Nov 27, 1961 - Three groins stranded offshore by retreat of west end of Washburn Island

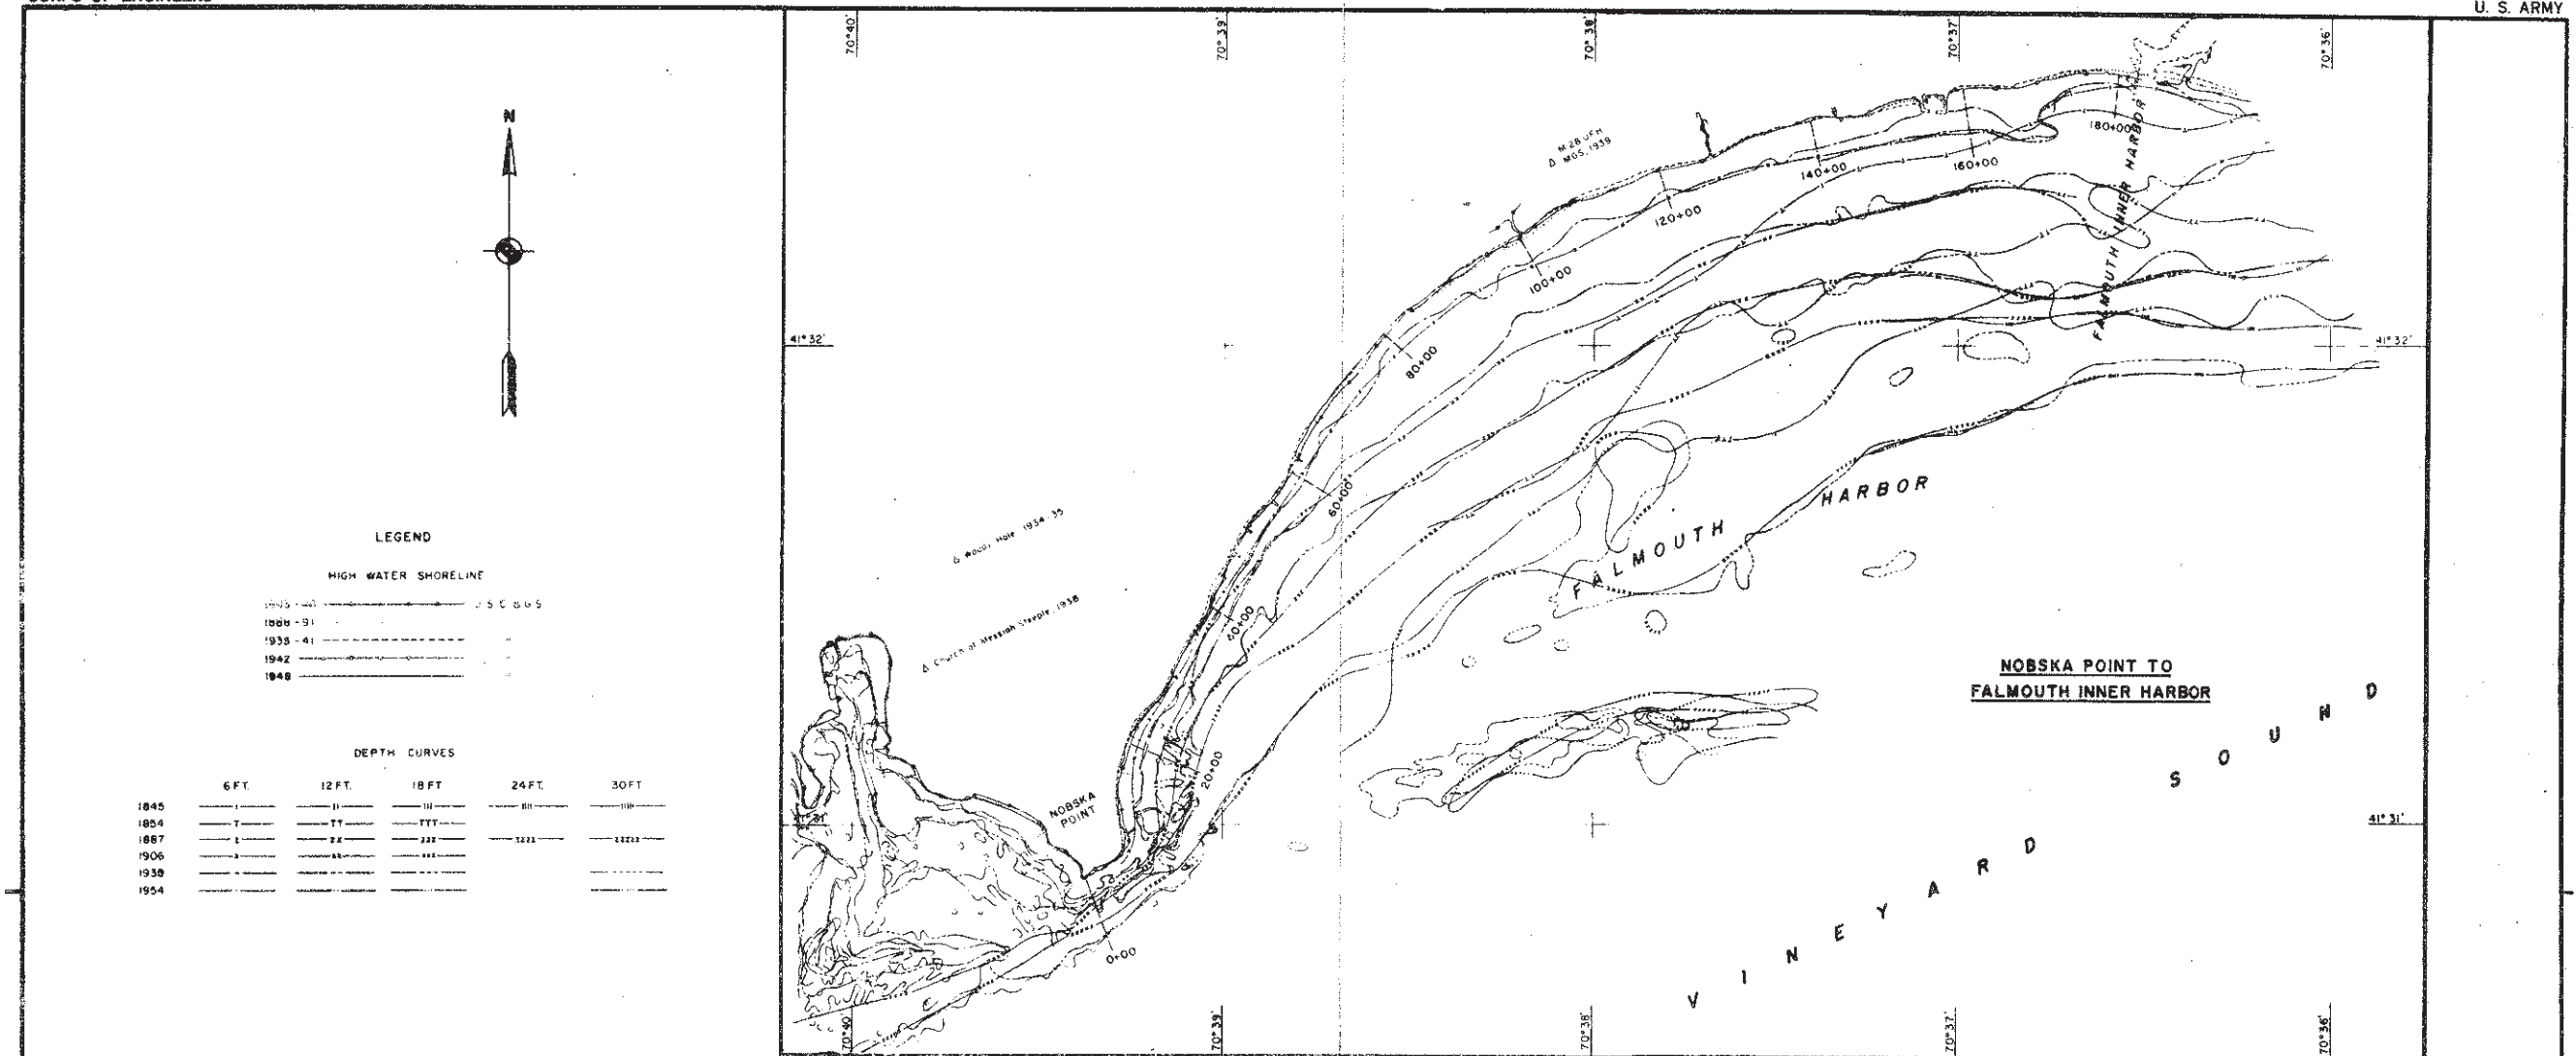
STATE OF MASSACHUSETTS
SHORELINE AND OFFSHORE DEPTH CHANGES
NOBSKA POINT TO WAQUOIT BAY
BEACH EROSION BOARD, WASHINGTON, D.C. JUNE 1961
POLYCONIC PROJECTION DATUM NA 1927
SCALE IN FEET
1:25,000
TRANSMITTED WITH REPORT
DATED: DECEMBER 28, 1962
FILE NO. B.E. MASS. 34
PLATE NO. 10

13. Shore History. - a. Shoreline Changes. - High water shoreline changes during the entire period of record from 1845 to 1961 were smaller along the study area west of Falmouth Inner Harbor than to the east. There was little change at the outer tip of Nobska Point and erosion and varying amounts of shore recession, not exceeding 100 feet, along most of the shore to the east to and including Falmouth Beach except for localized areas at the west sides of groins and similar structures where impounded material caused short segments of the shoreline to move seaward. Recession of the shore, generally less than 50 feet, occurred along the shore between Falmouth Beach and Falmouth Inner Harbor except adjacent to the west Falmouth Harbor jetty where impounded material moved the shore up to about 200 feet seaward. The Falmouth Heights shore was eroded between 1845 and 1941 resulting in landward shore movements of up to about 150 feet but during 1961, as a result of direct placement of sand on the beach during 1957, and subsequent drifting, parts of this shore were up to about 150 feet seaward of their 1941 position. From 1845 to 1961, the Mara Vista shore moved 50 to 100 feet landward, the Acapesket shore receded 150 to 500 feet, the greater recession along the easterly third of the area, the Davisville shore receded 100 to 400 feet, the larger movement at the west end, the Menauhant shore receded 100 to 250 feet and the Washburn Island shore moved landward along its west half up to about 700 feet and the shore along the east half moved seaward up to about 500 feet, the latter accretion as a result of impounding of material at the Waquoit Bay west jetty. Changes in recent years (from 1938-1942 to 1961) have been influenced by the construction of various types of protective works. Large or significant changes during this period have consisted of accretion at the west sides of groins between Nobska Point and Falmouth Beach, at the west side of the Falmouth Inner Harbor west jetty, along most of the Falmouth Heights shore, at the west side of the Waquoit Bay west jetty and recession at the east and west ends of the Acapesket shore and at the west end of the Washburn Island shore at the Eel Pond entrance.
